# ITS Intertek Testing Services ETL SEMKO

3033871

Interim Pour-in Place Forming Capacity Testing

NUDURA Corporation

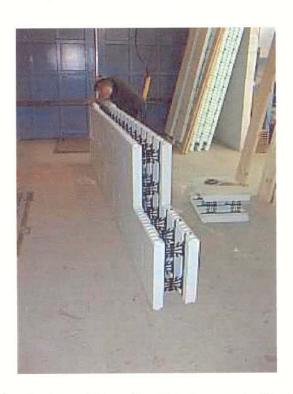
Photograph No. 1: Assembling of insulated concrete form wall modules

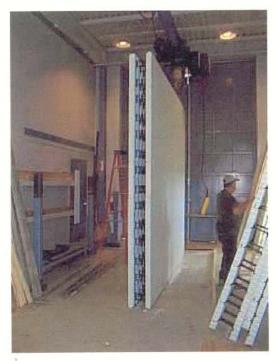
Photograph No. 2: Wall assembly before bracing and end caps installed.

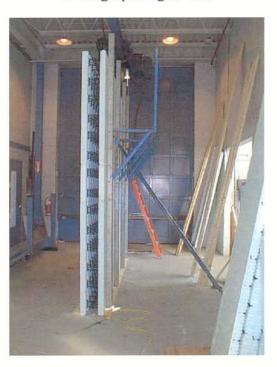
Photograph No. 3: Wall assembly with bracing attached.

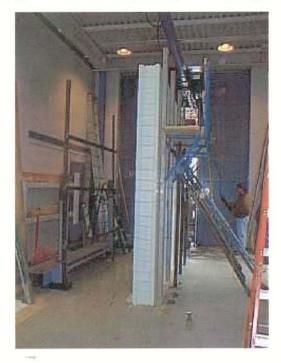
Photograph No. 4: Wall assembly before concrete pour.

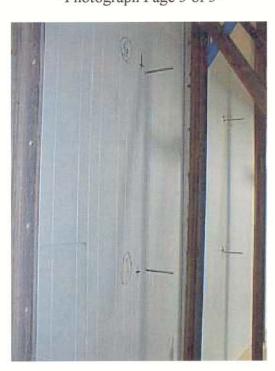
Photograph No. 5: 500 mm measuring rods on braced surface.

The client assembled the wall complete with bracing and platform on one face. The opposite face was not braced. Reference marks were made on the wall surface at 1/4, 1/2, and 3/4 the height and width of the wall. A measured 500 mm long by 6 mm diameter steel rod was inserted through the wall at these locations to measure any change of thickness of the wall with our Mitutoyo Digital vernier caliper (280 01 0108). Vertical and horizontal bow was measured on the non braced surface with a 3 metre straight edge and steel ruler. Deviation from plumb was measured with plumb line and steel ruler on the non braced surface of the wall. Measurements were taken before the concrete was pumped into the wall cavity. Measurements were again taken after the first lift of 1.6 metre high of concrete was poured into the form, after the second lift filling form with concrete to 3.2 metres high, and after 3 days of curing. The consolidation of the concrete during the pouring of the concrete was with mechanical vibration using a 1-inch head, duration of 40% of placing time, and depth of vibration of 1.25 m. This was followed by an undisturbed period of 15 to 30 minutes.

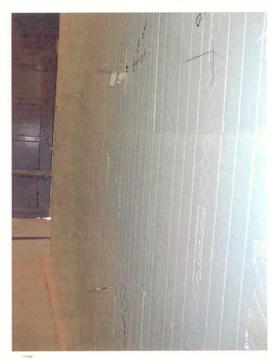
Photograph No. 6: 500 mm measuring rods on non braced surface.
